Oiling & Valve Train Issues & Solutions

Solutions Engineered for
Twin Cam™ Engines, Based on
Commonly Found Problems in the
Field

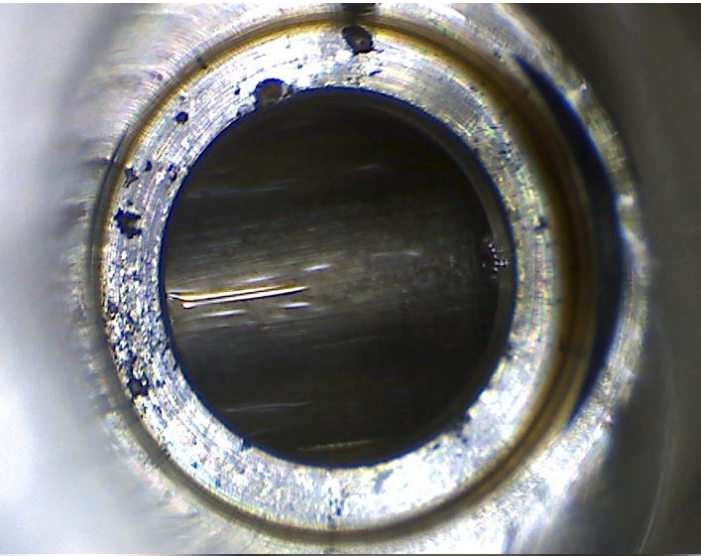
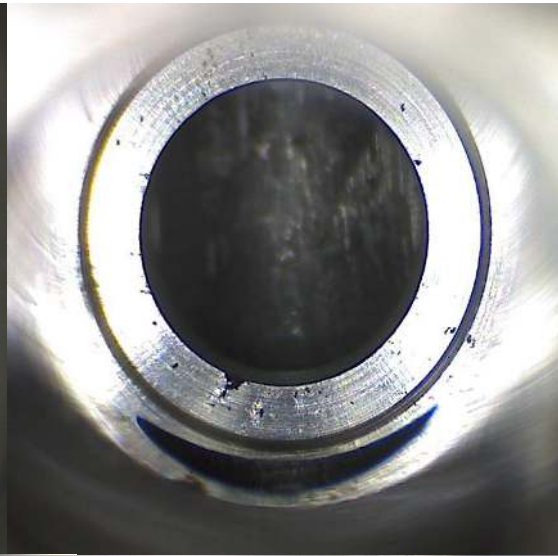
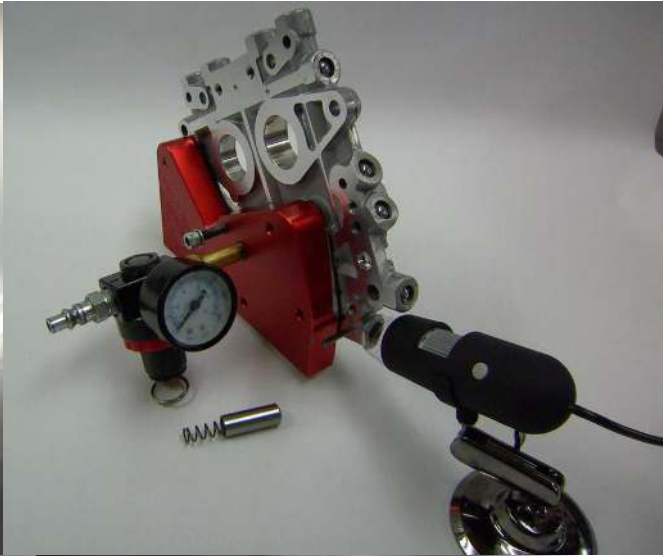
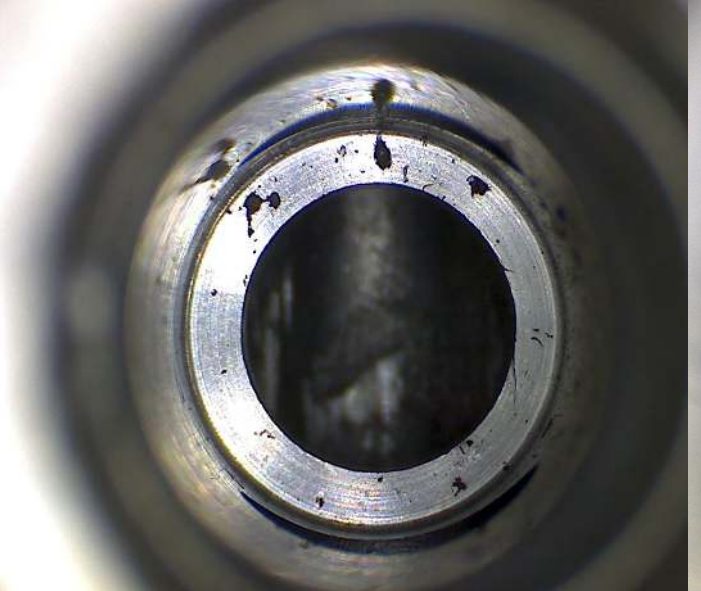
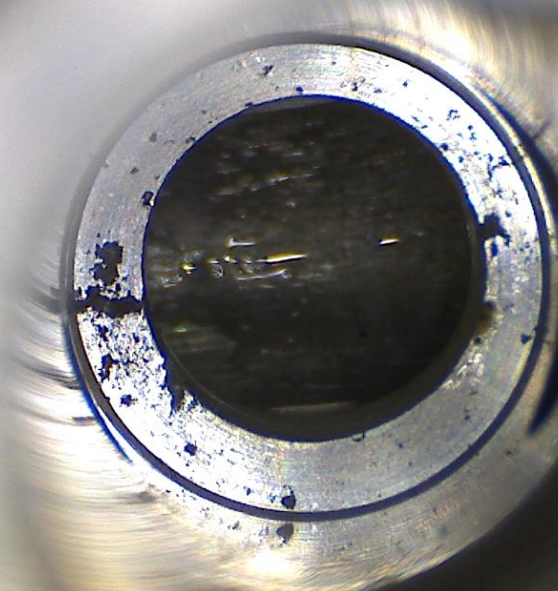
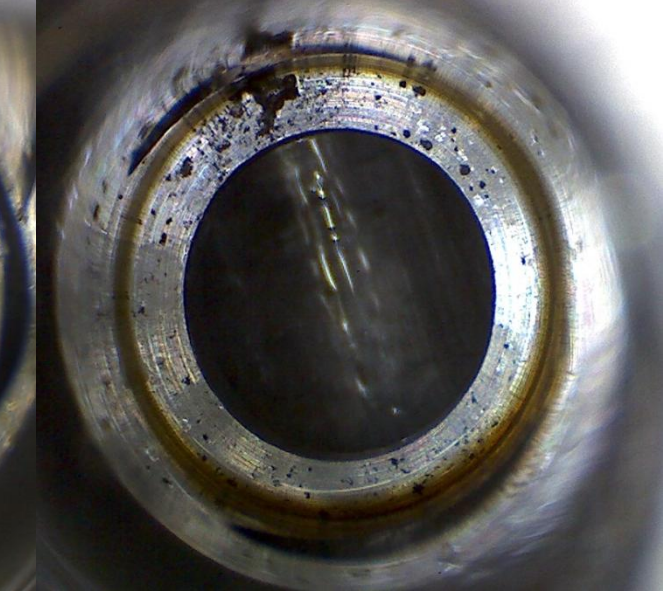
Typical Porosity Found in OE Cam Support Plates, Magnified Oil Pressure Relief Valve Seat

- Porosity in the Cam Support Plate at the Seat
 - Investment Castings are known for Porosity Issues
- Non-Repairable in most cases
 - A proper Seat Angle cannot be added
 - Material Crumbles away after use
 - Material Missing on the Seat Surface

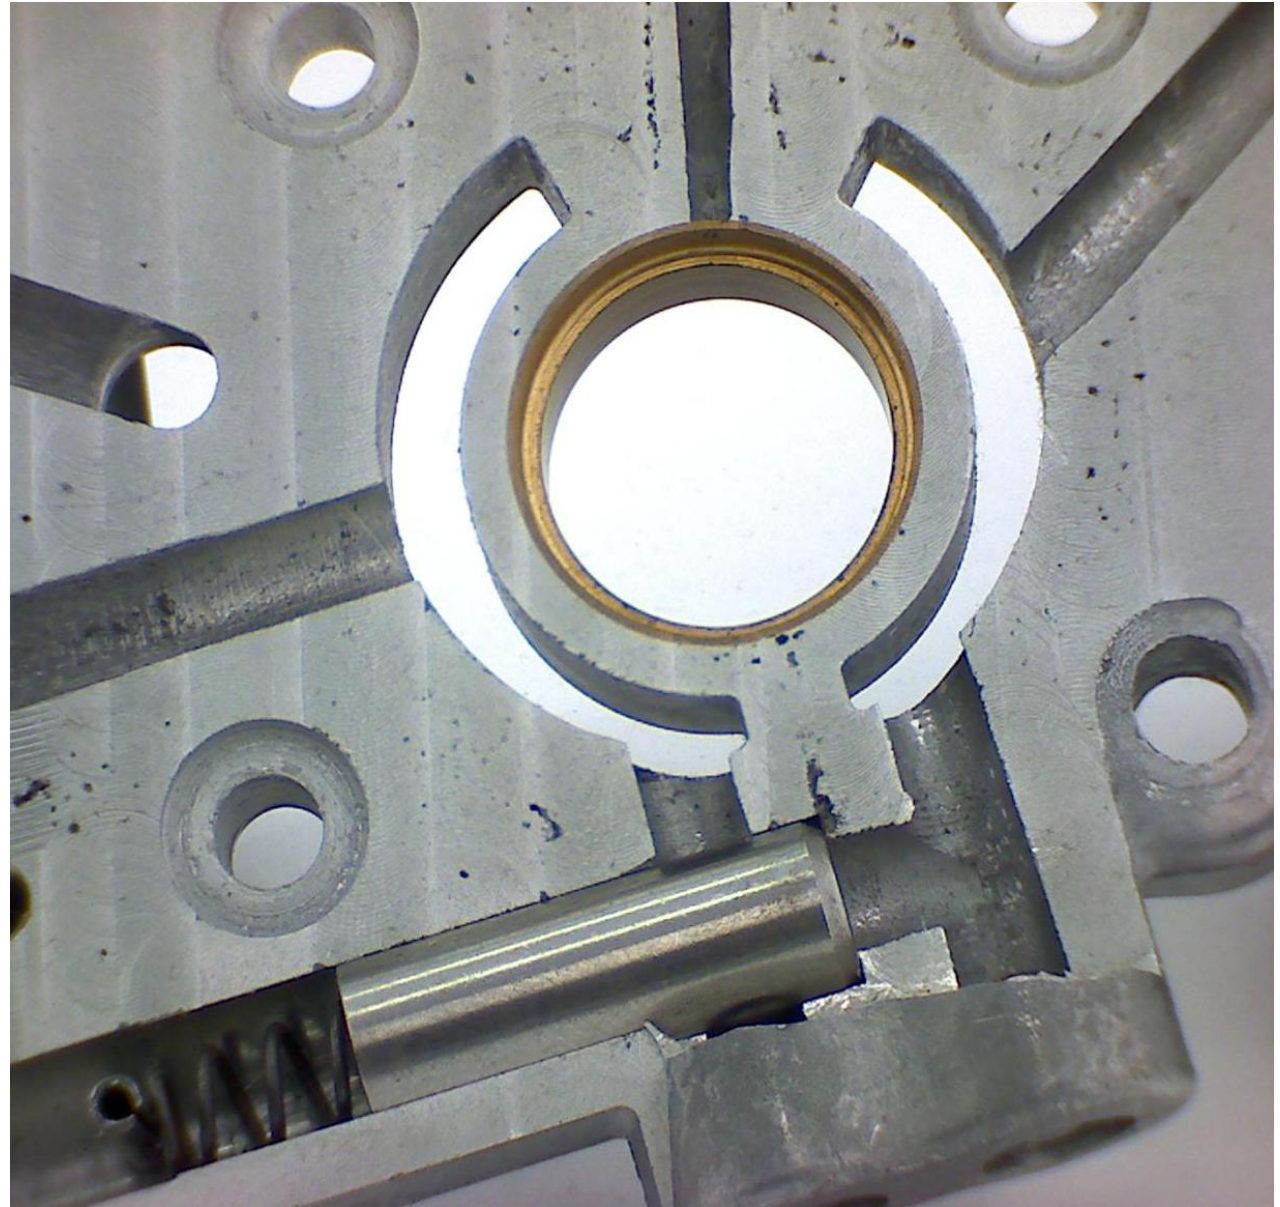
OE Cast Cam Support
Plate – Cutaway View

Note the Extent of
Porosity Through the
Entire Casting, and the
Significant Void at the
Oil Pressure Relief
Valve Seat

This is the Key
Component in Oil
Distribution in the Entire
Engine, and one of the
Largest Sources of
Internal Leaks.

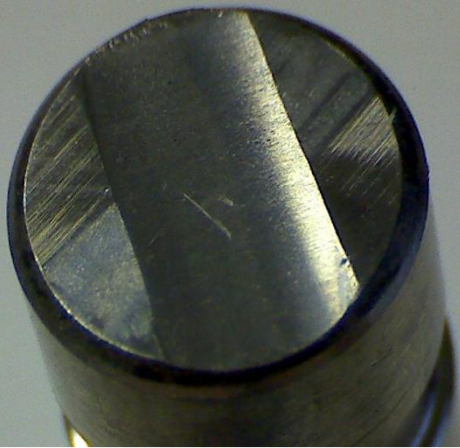
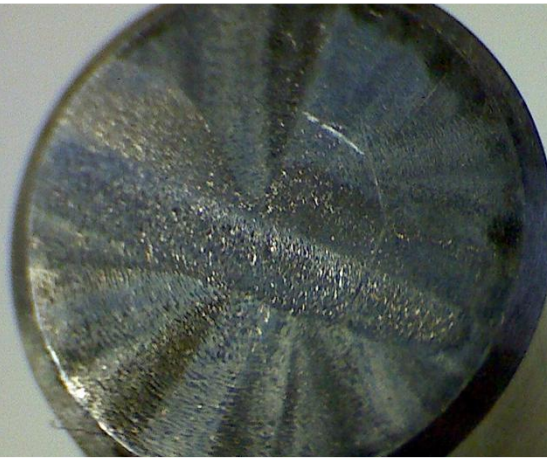
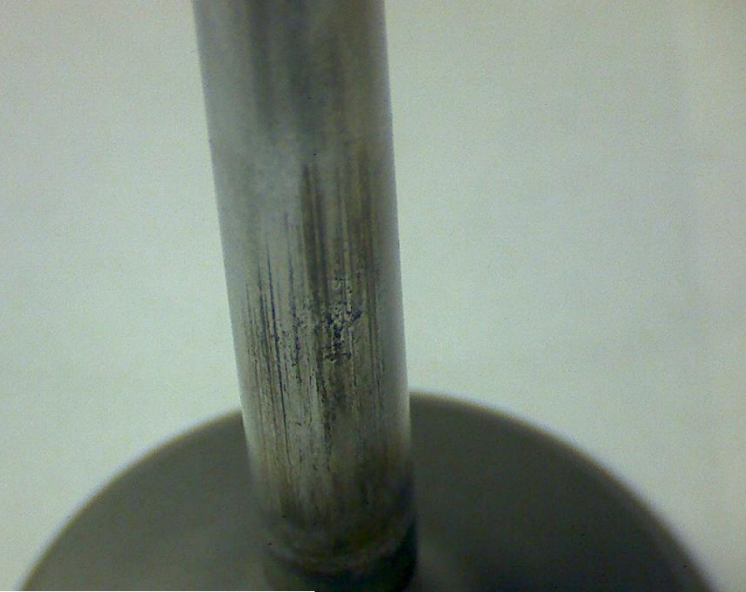
Accelerated Internal Wear – Valve Stems & Tips, Rocker Arm Tips & Bushings, Lifters

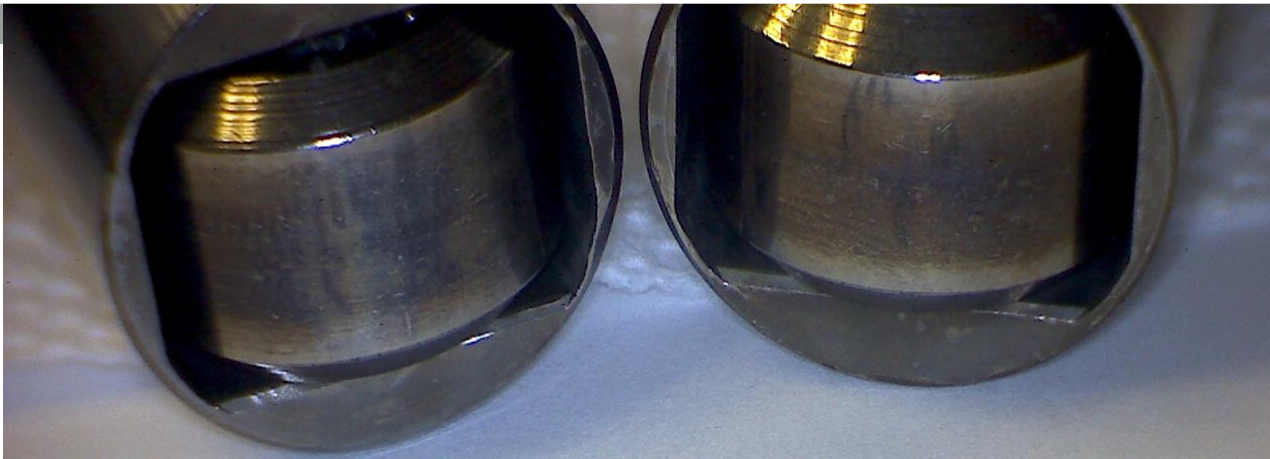
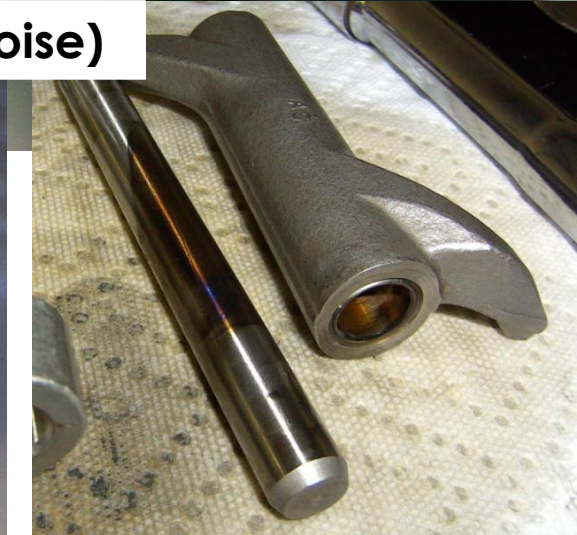
Increased Heat & Stress on High Pressure Components (Noise)

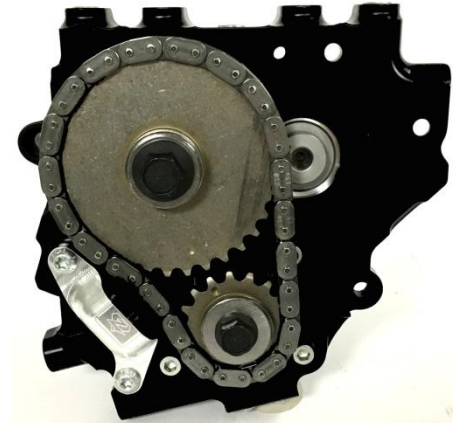
- **Concentrically Ground Plunger Valve**

- Creates Proper Seal Inside Cam Support Plate
- Reduce and Eliminate Leaks at Low RPM

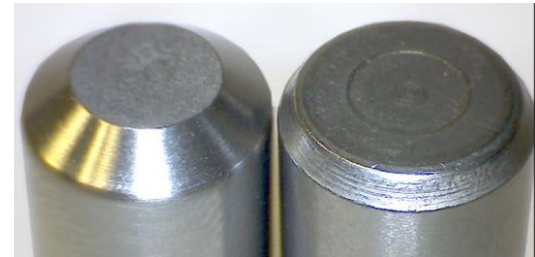
- **Increased Spring Pressure**

- Multiple Springs
 - Customize the Blow-Off Pressure
- OE, LMR2, LMR4, Fueling, Zipper's Shim

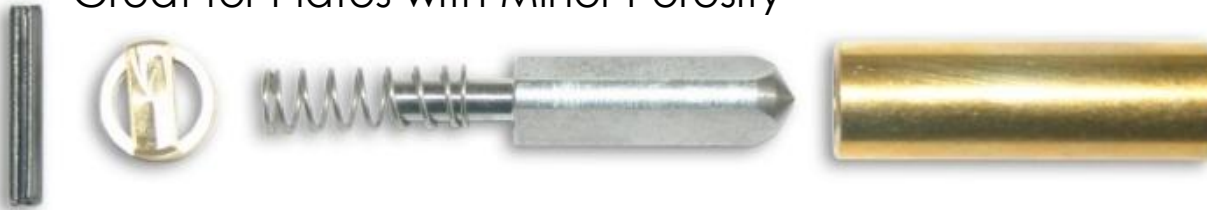
- **Axtell Device for Porous Cast Plates**

- Cartridge Style Relief Valve
- Returns Oil to Cam Chest
 - Not Back into the Pump
- Reduced Oil Aeration
- Alternative to Full Cam Support Plate Replacement

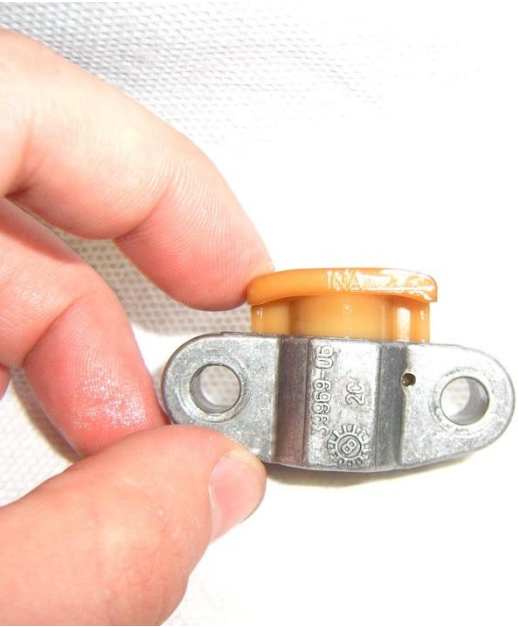
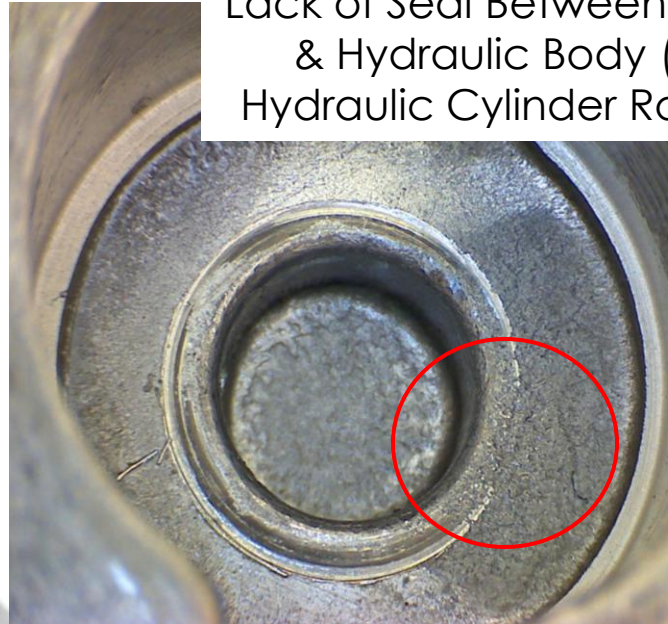
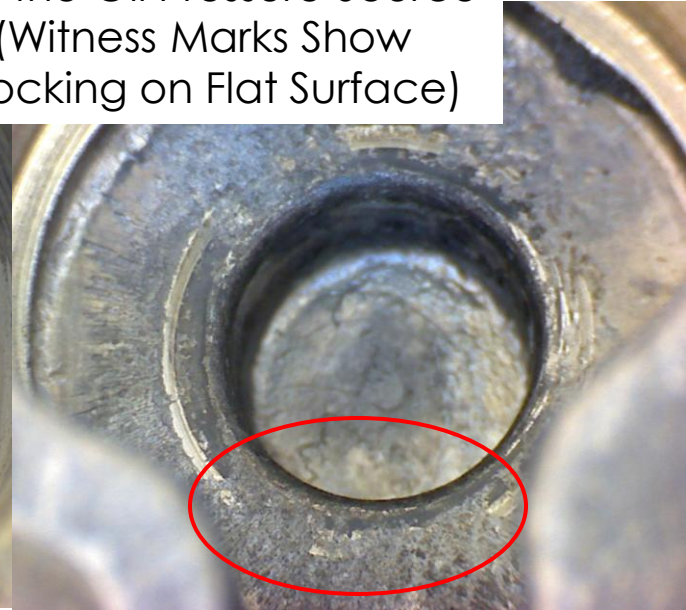
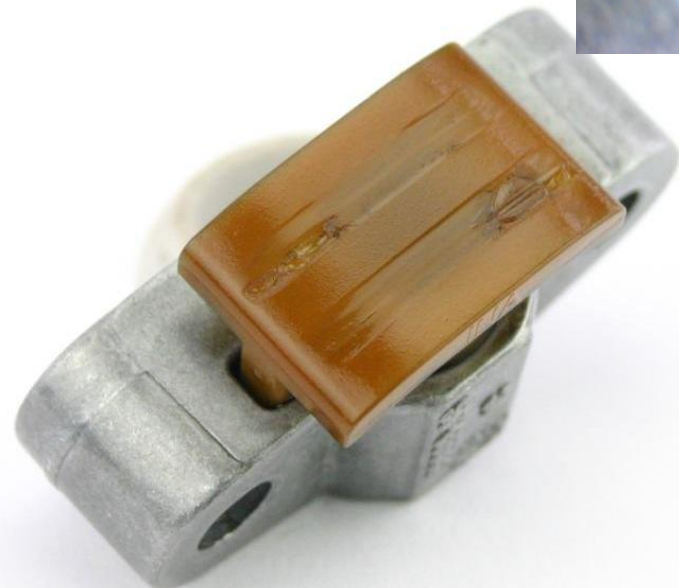
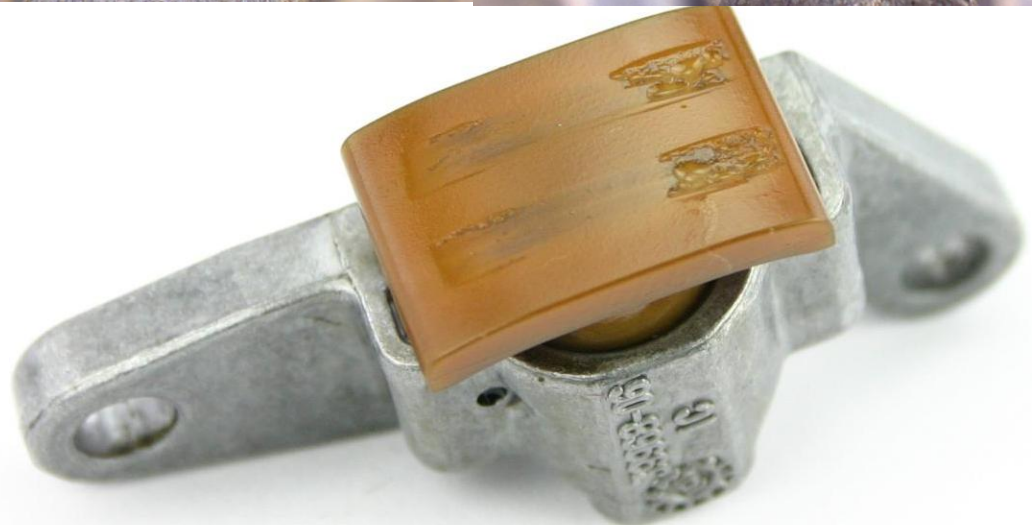
Lack of Seal Between the Oil Pressure Source & Hydraulic Body (Witness Marks Show Hydraulic Cylinder Rocking on Flat Surface)

- **Loss of Hydraulic Pressure**
 - Loose Manufacturing Allows Hydraulic Circuit to Leak
 - Rocking Motion of Shoe Breeches Hydraulic Rail Pressure
 - Once Airbound, Very Difficult to Regain Control
- **Sticking OEM Cam Chain Tensioner Shoes**
 - Noticeable Changes Made in Production
 - Coarser ID Finish in Factory Cast Body
 - Can Cause the Shoe to Stick in the Body
 - Complete Loss of Control of the Valvetrain
 - Excessive Noise & Component Damage
 - Unacceptable Valvetrain & Cam Chest Noise

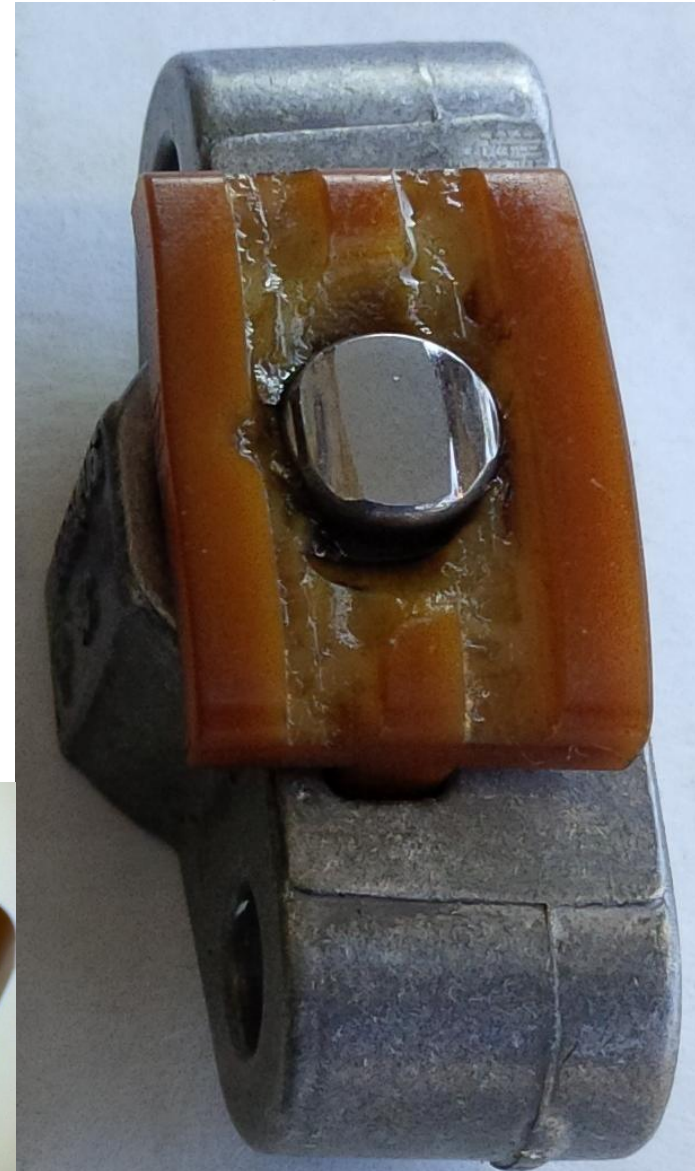
When Tipped 2° , the Oil Pressure Source is Compromised to the Hydraulic Body

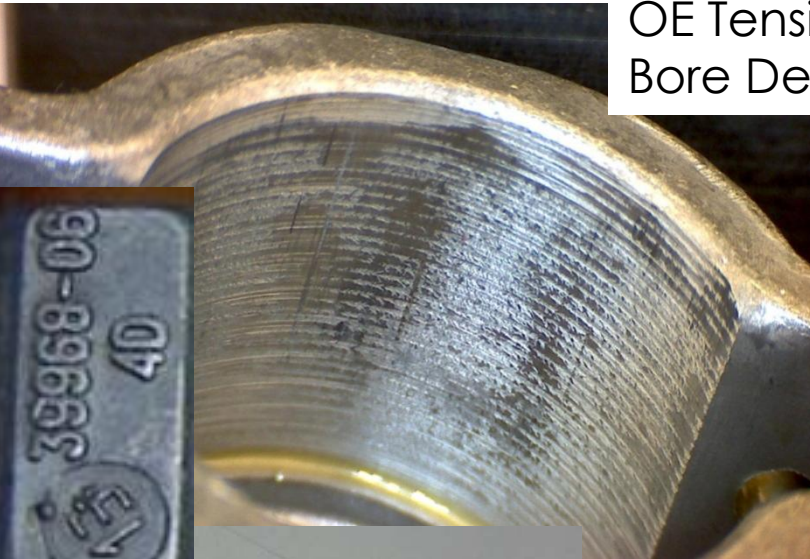
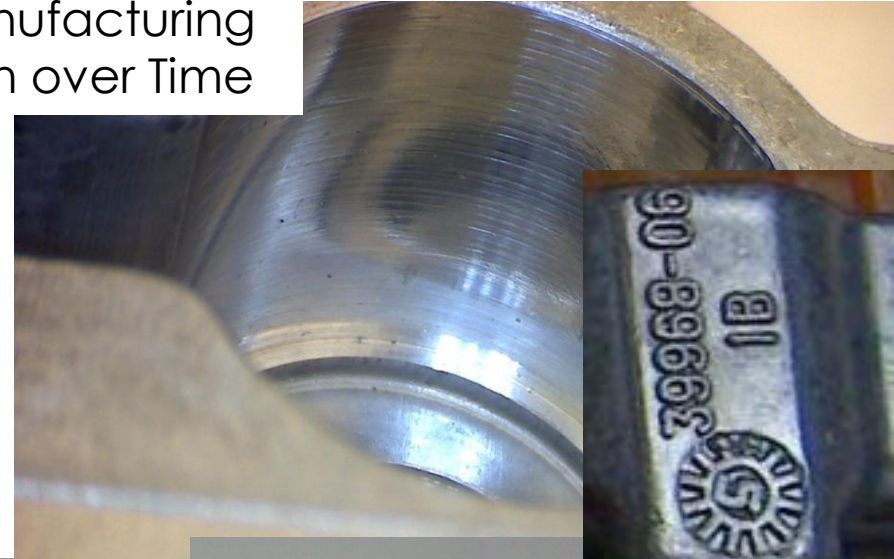
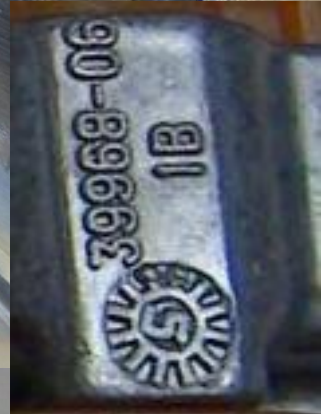
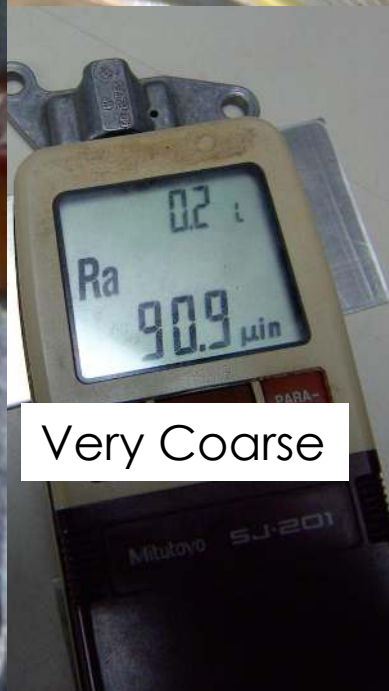
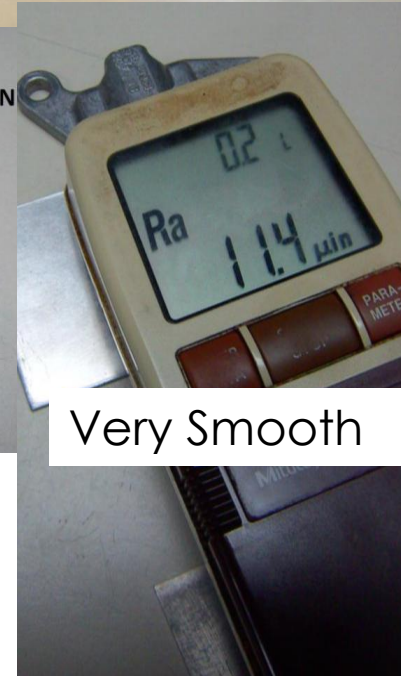
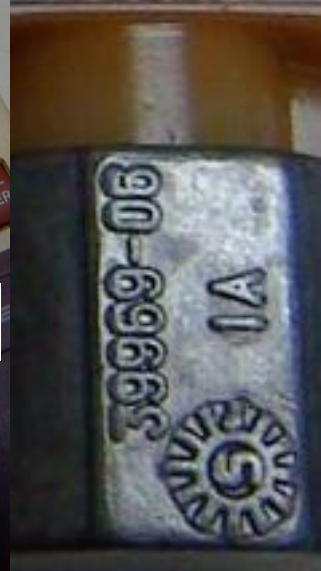
OE Tensioner Manufacturing
Bore Degradation over Time

Very Coarse

"4D"
LATE TC PRODUCTION

"1A" & "1B"
EARLY TC PRODUCTION

Very Smooth

Sticking Late Model
"3A & 4D" OE Cam
Chain Tensioners

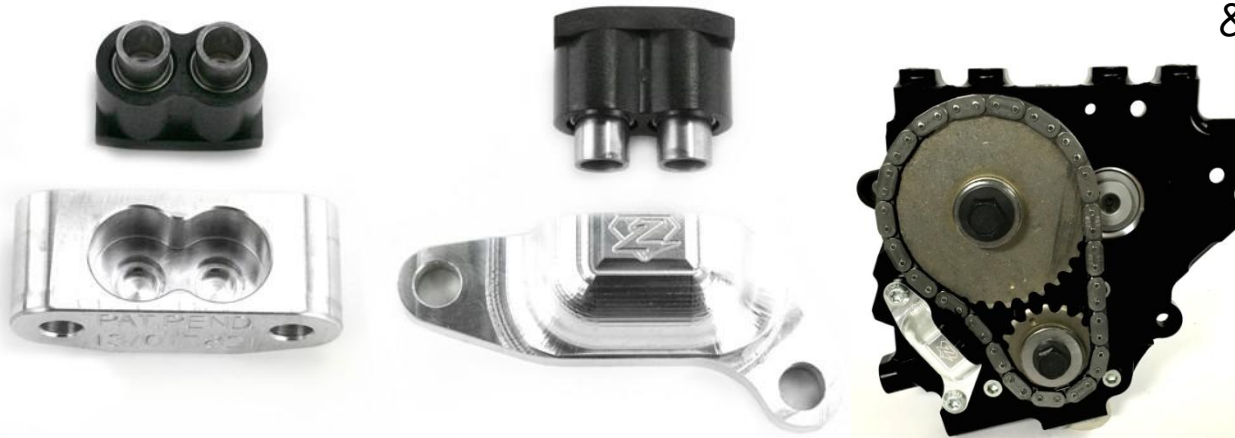
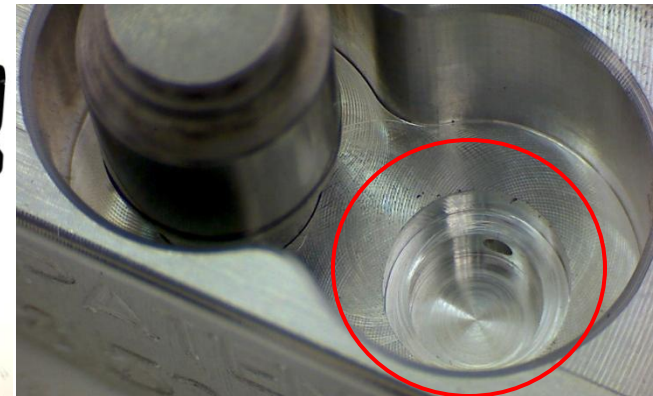
Intelligent Design Captures & Seals Hydraulic Cylinder

- Dual Piston Design Eliminates Chain Instability & Tensioner Shoe "Rocking"
 - Maintains Hydraulic Pressure in Lower Oil Pressure Scenarios
 - Dual Feed Provides a Larger Reservoir of Oil
- Accurate Cam Timing Events for Both Cylinders
- Tolerates Common Crankshaft Run-Out (Unlike Gear-Drive Cams)
- Improves Throttle Response, Acceleration and Across-The-Board Power
- Precision CNC Machined, Made From Superior Materials

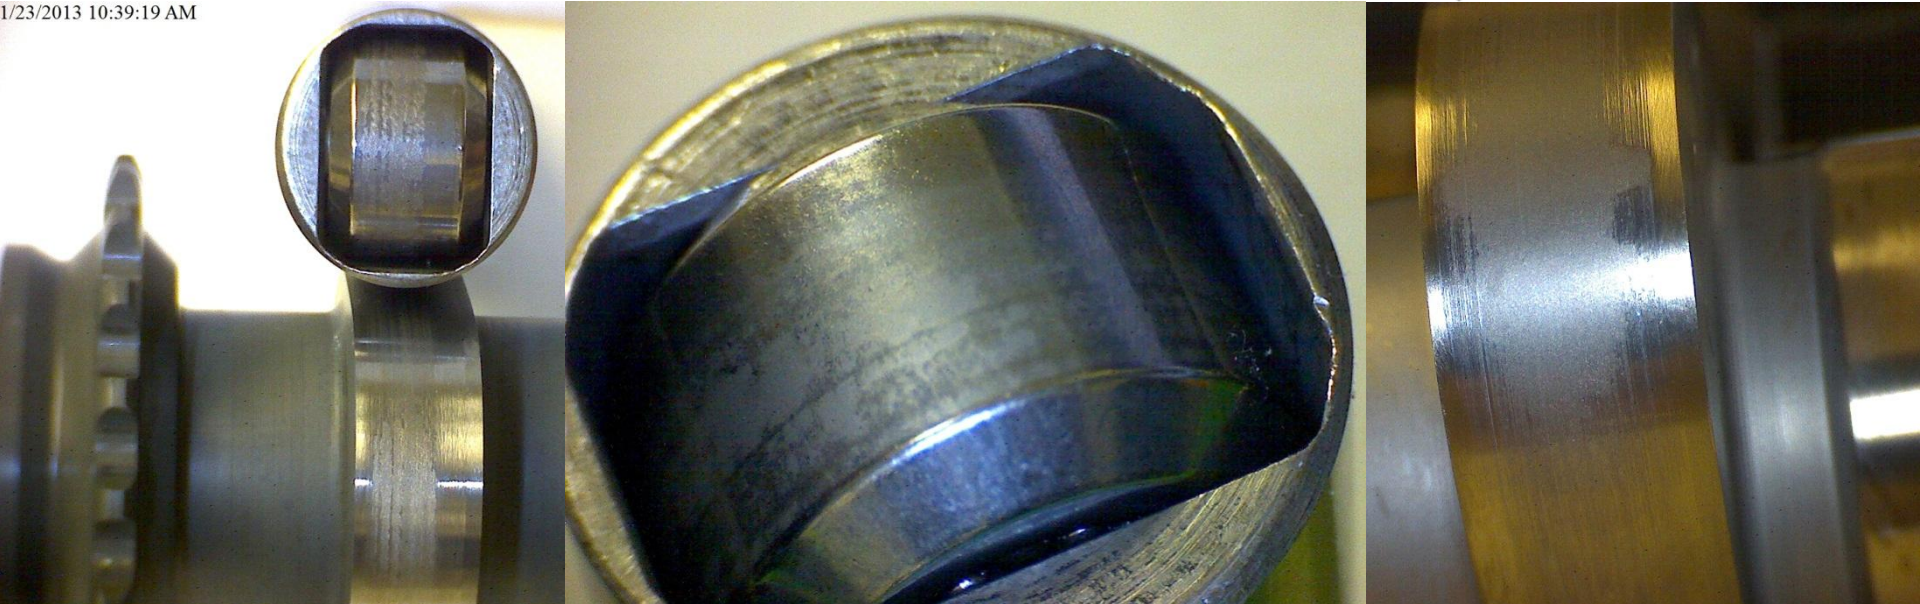
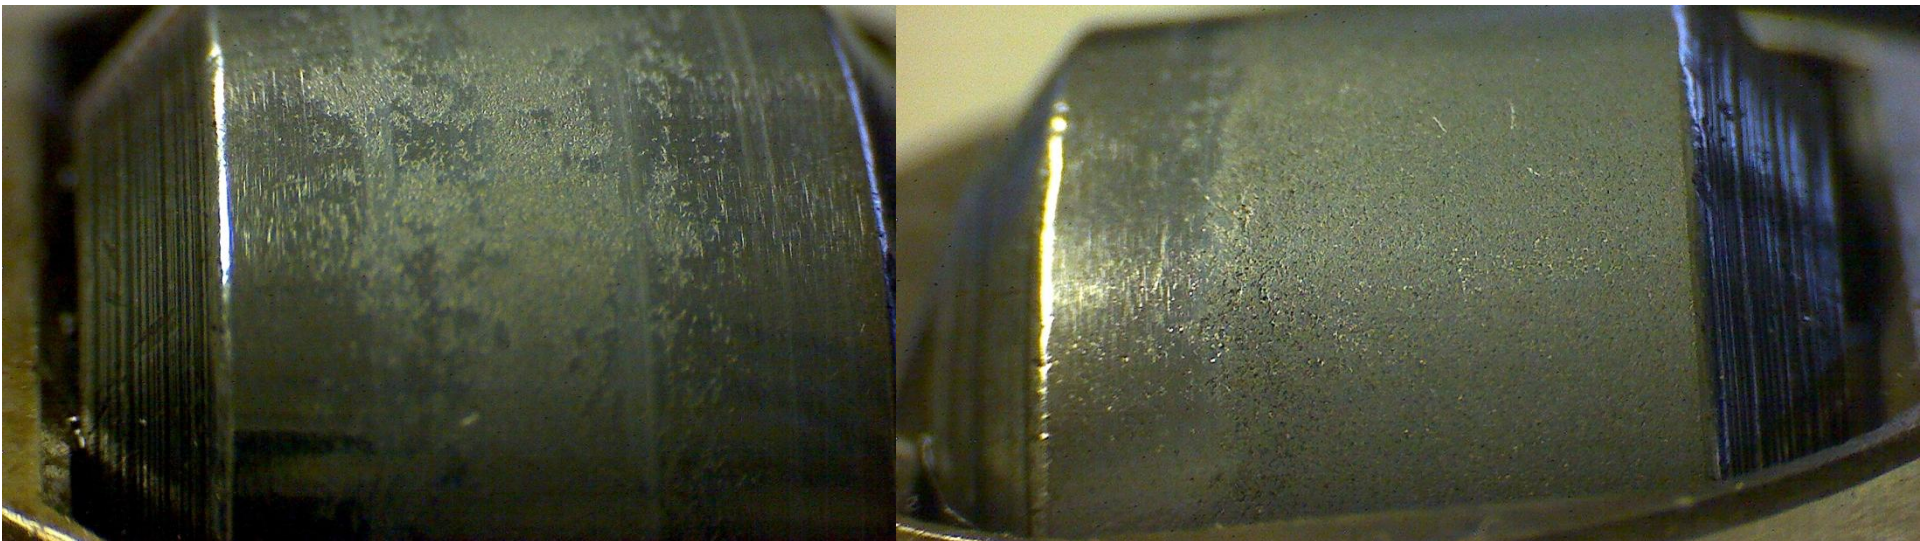
Material Transferring from the Roller onto the Camshaft, Rarely the Other Way Around

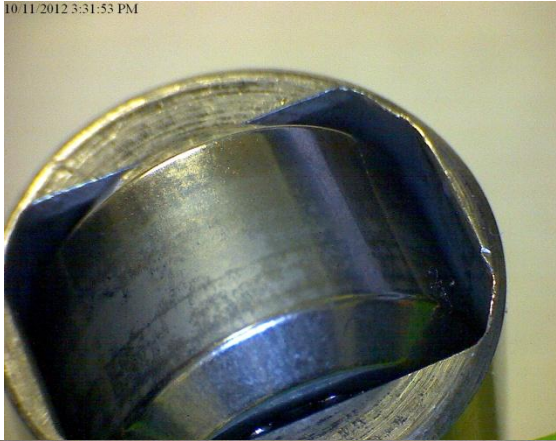
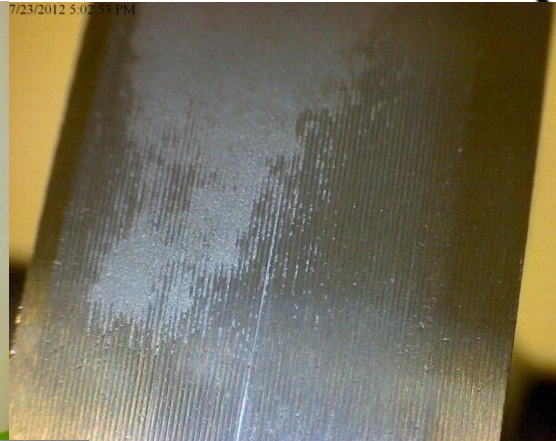
**2012 OE
Lifters
1,400 Miles**

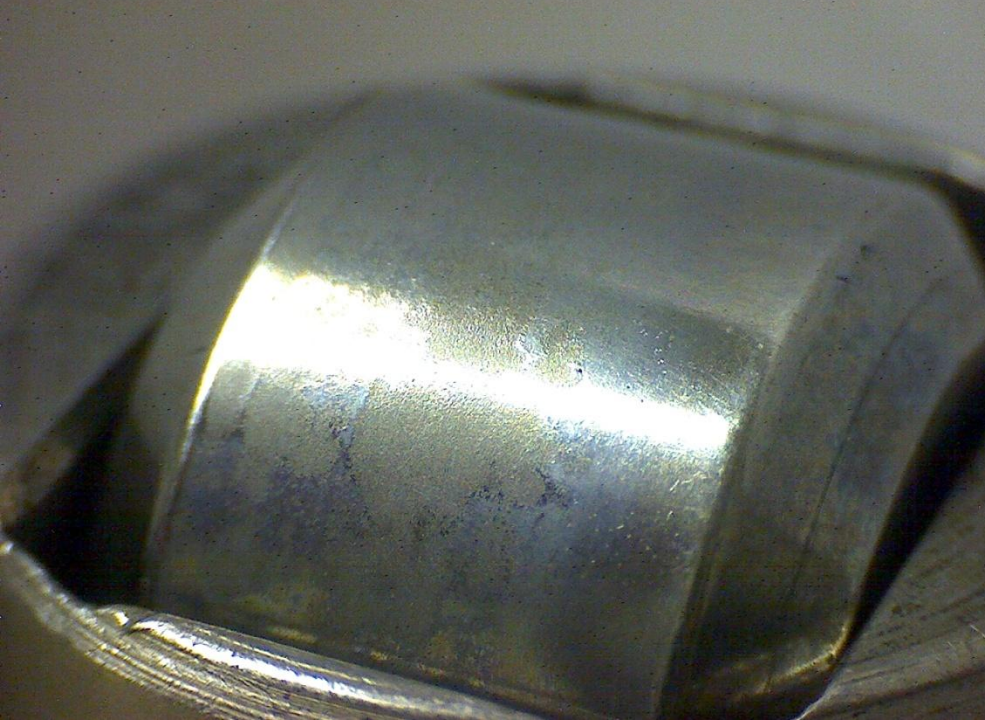
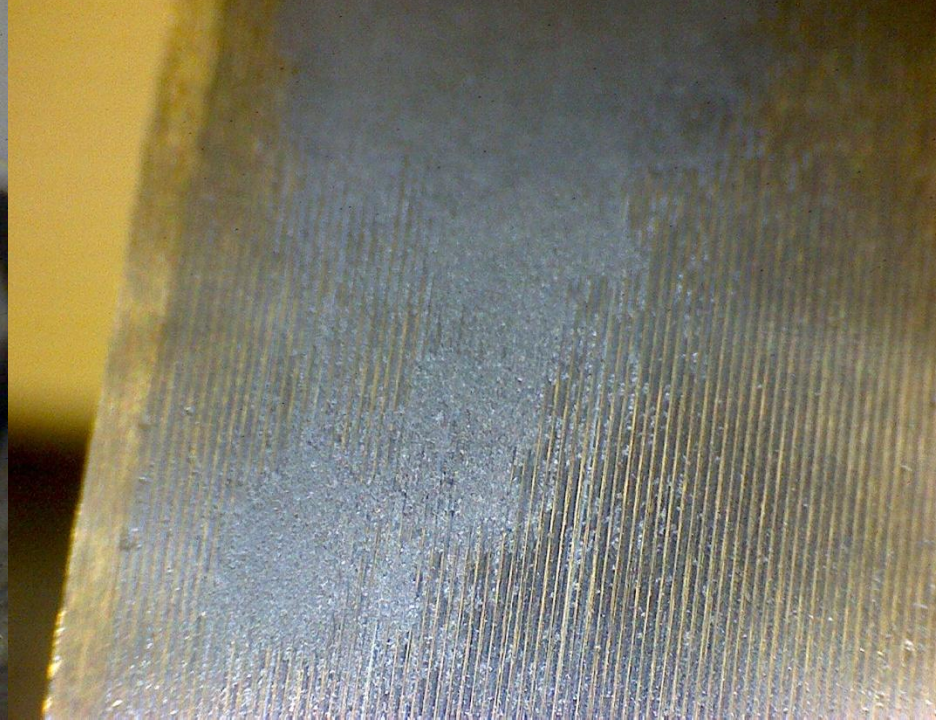
**2012 OE
Camshaft
1,400 Miles**

Material Transferring from the Roller onto the Camshaft

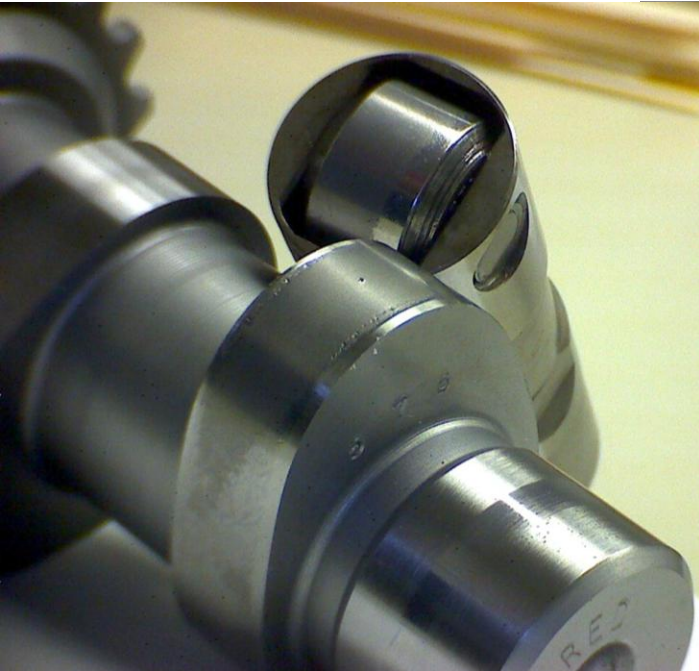
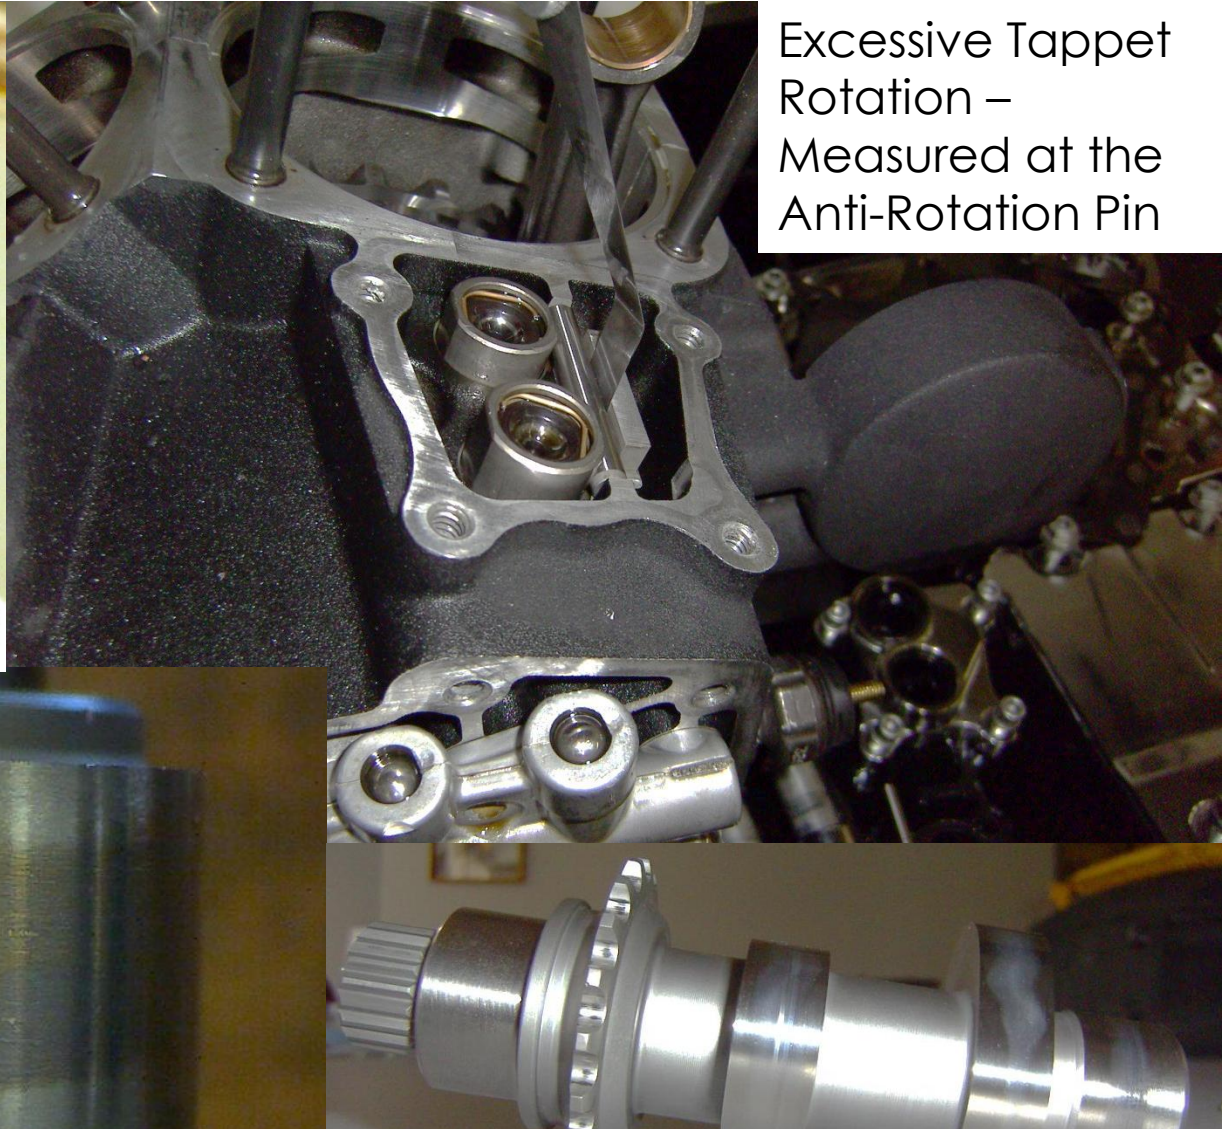
Excessive Tappet Rotation –
Measured at the
Anti-Rotation Pin

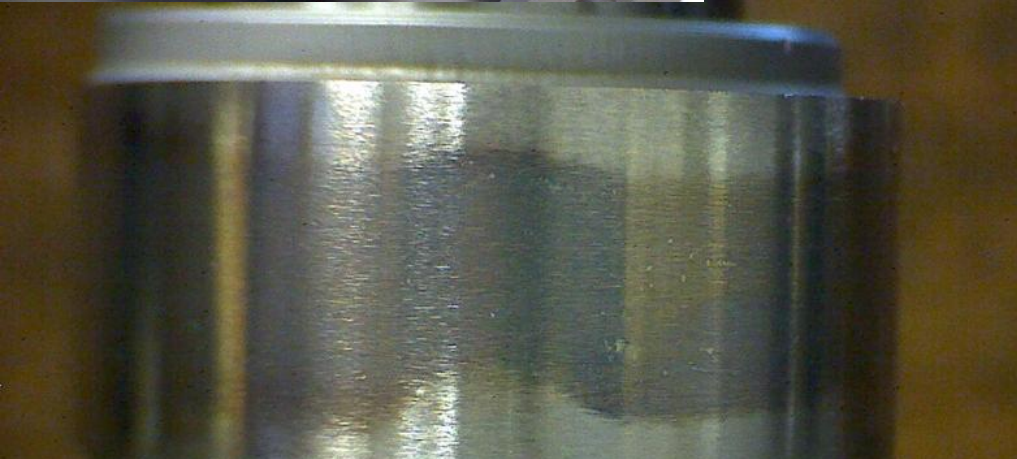
Excessive Tappet Rotation – Path of Roller Shown on Camshaft
